New York State Department of Transportation

Yellow Flag NB2358W015

BIN: 1065318

Location: Span 247, Girder G1 at Pier 247

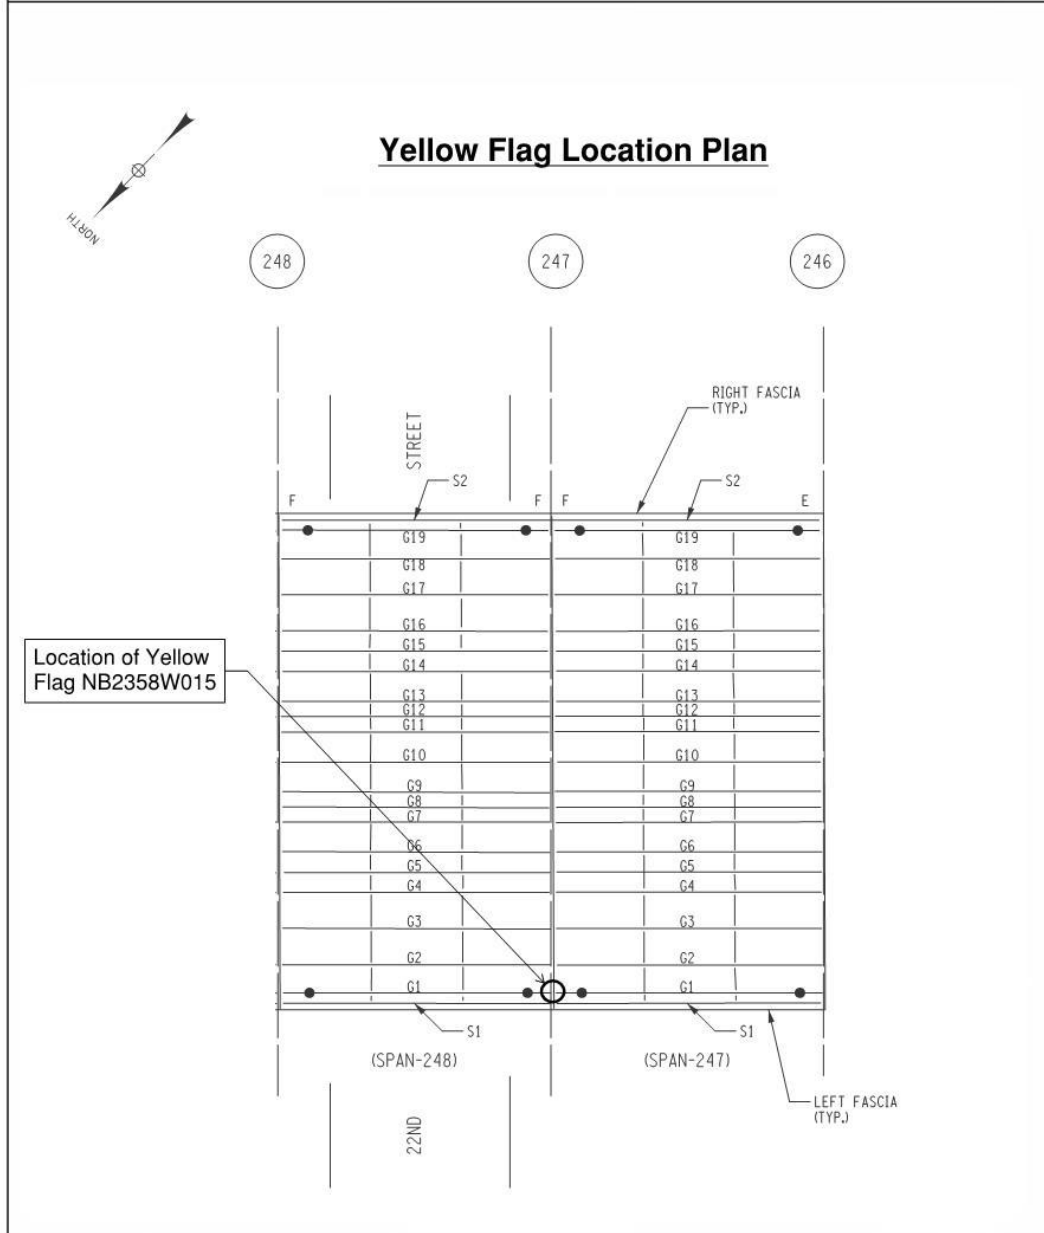
Flag PhotographsPhoto Number: **1**Photo Filename: **23_Flag Location Plan.jpg**Gowanus Expressway
2023 Biennial Inspection - Field SketchBIN: 1065318Team: AA/TSDate: 05/31/2023Span: 247Location: Girder G1 at Pier 247

**wsp****Attachment Description: Flag Location Plan**

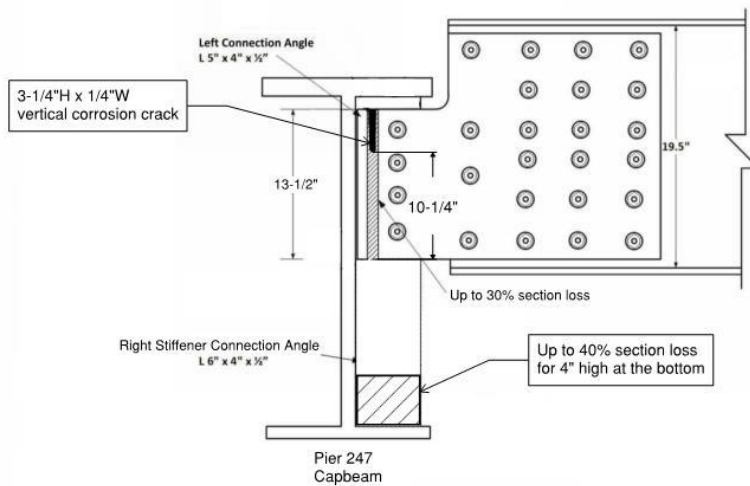
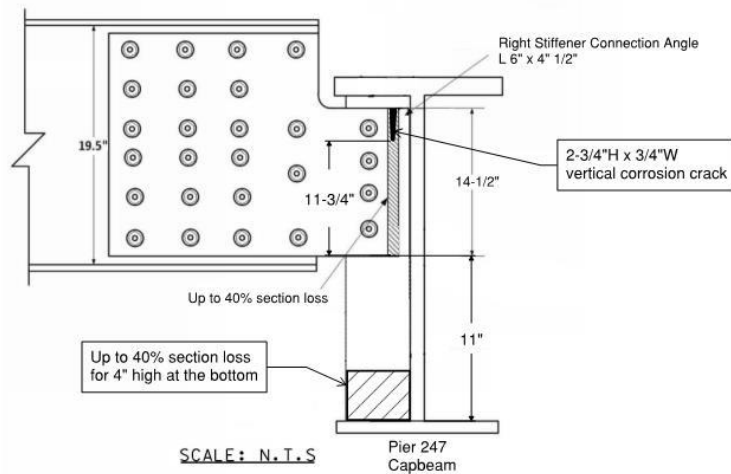
Photo Number: 2

(refer to Yellow Flag Condition Sketch Photo #2 for more details)

Left Face of Girder G1

Right Face of Girder G1

-As-measured web thickness is approximately 0.606"

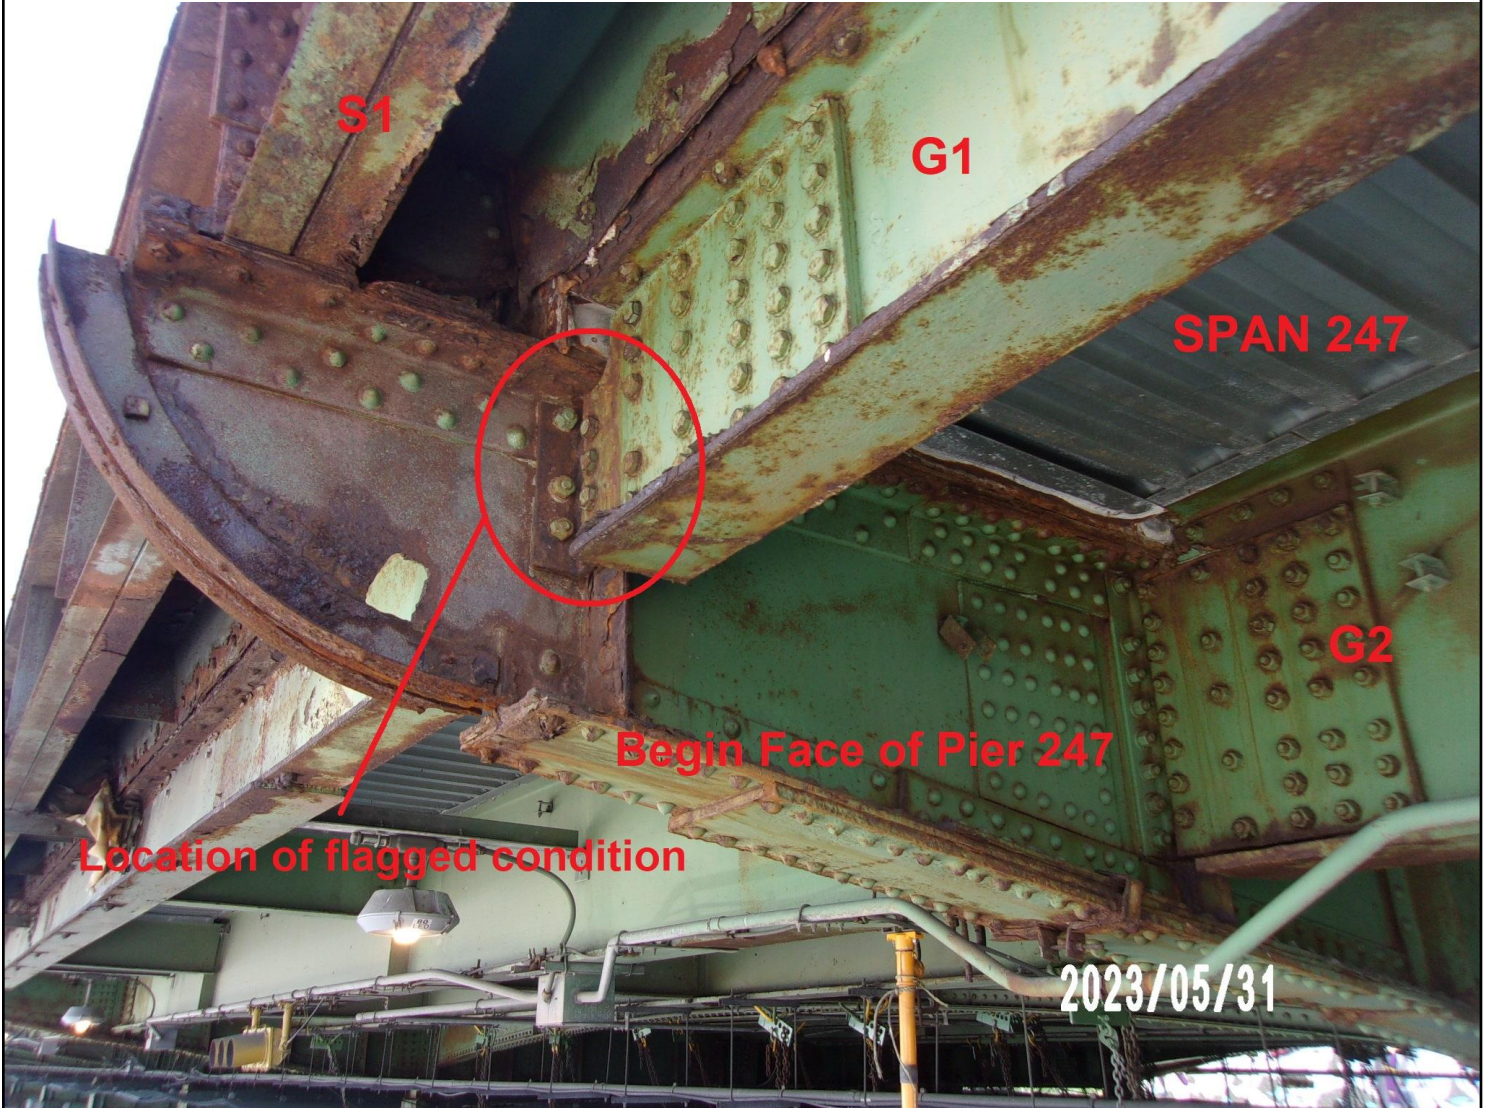
Photo Number: 3

Attachment Description: General view of the flagged condition at Girder G1 in Span 247 at Pier 247. Looking End.

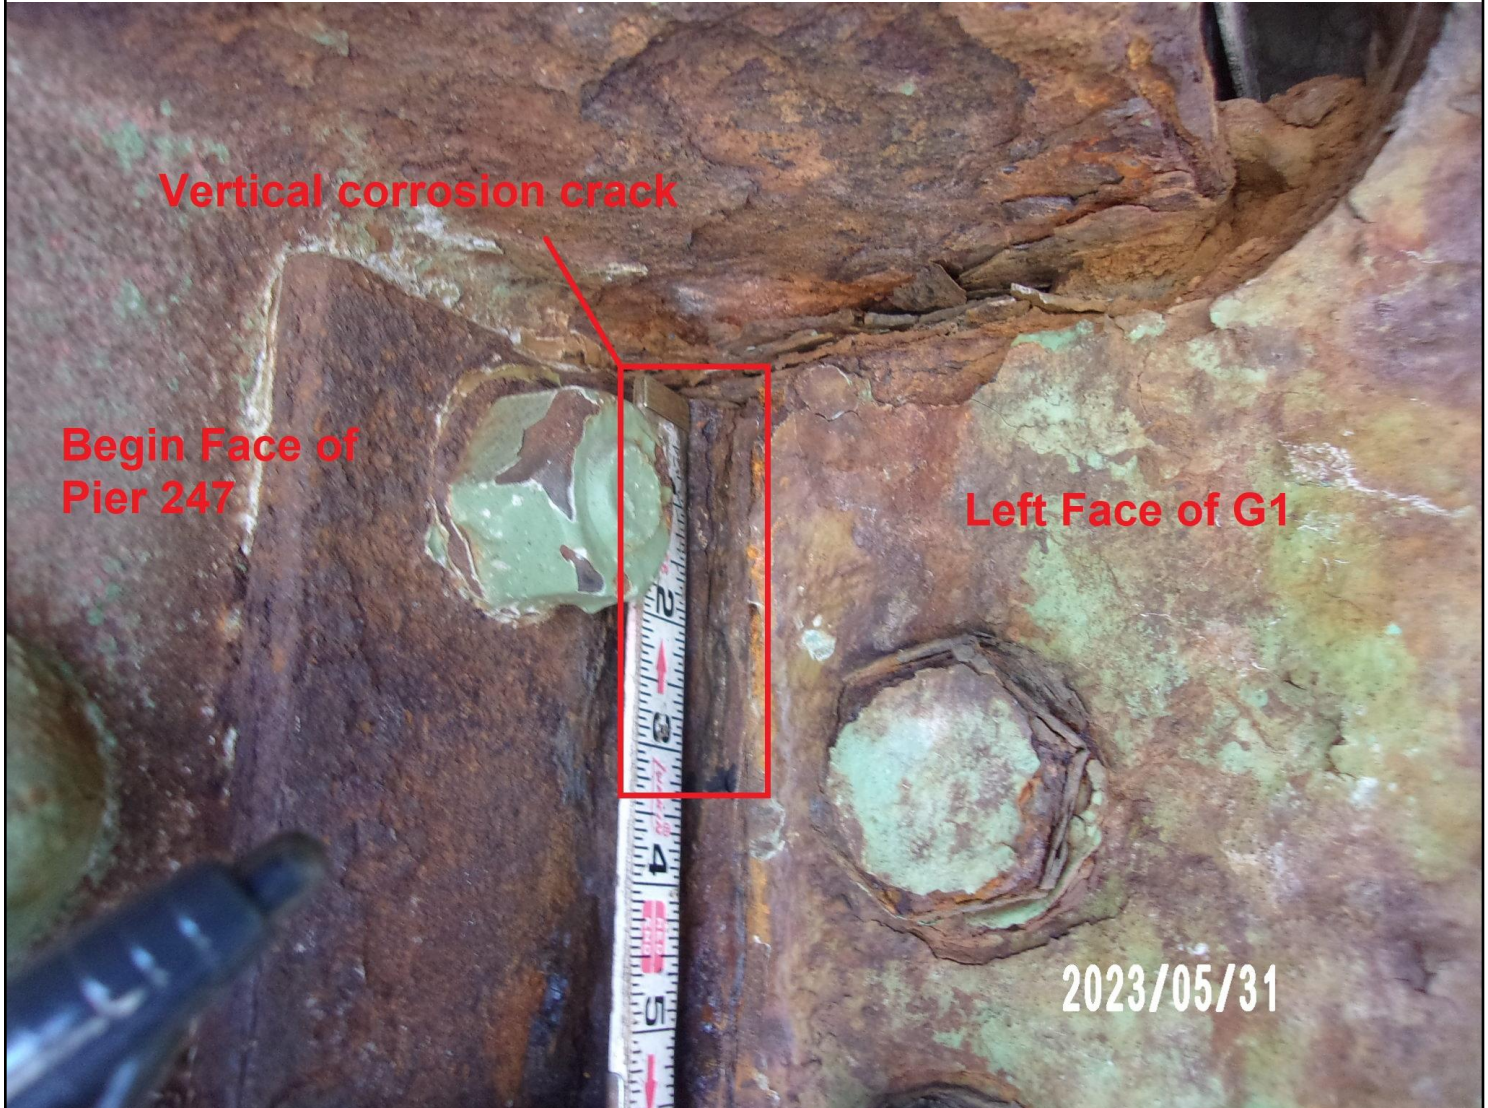
Photo Number: 4

The left connection angle at Girder G1 connection to the pier cap at Pier 247 exhibits a 3-1/4"H x 1/4"W vertical corrosion crack at the upper fillet section (Photo 4). The remaining 10-1/4" area of the fillet section below the corrosion crack at the top of the angle exhibits up to 30% section loss (Photo 5).

Attachment Description: The left face of Girder G1 in Span 247 at Pier 247. The top of the left connection angle exhibits 3-1/4"H x 1/4"W corrosion crack at the fillet section. Looking Right.

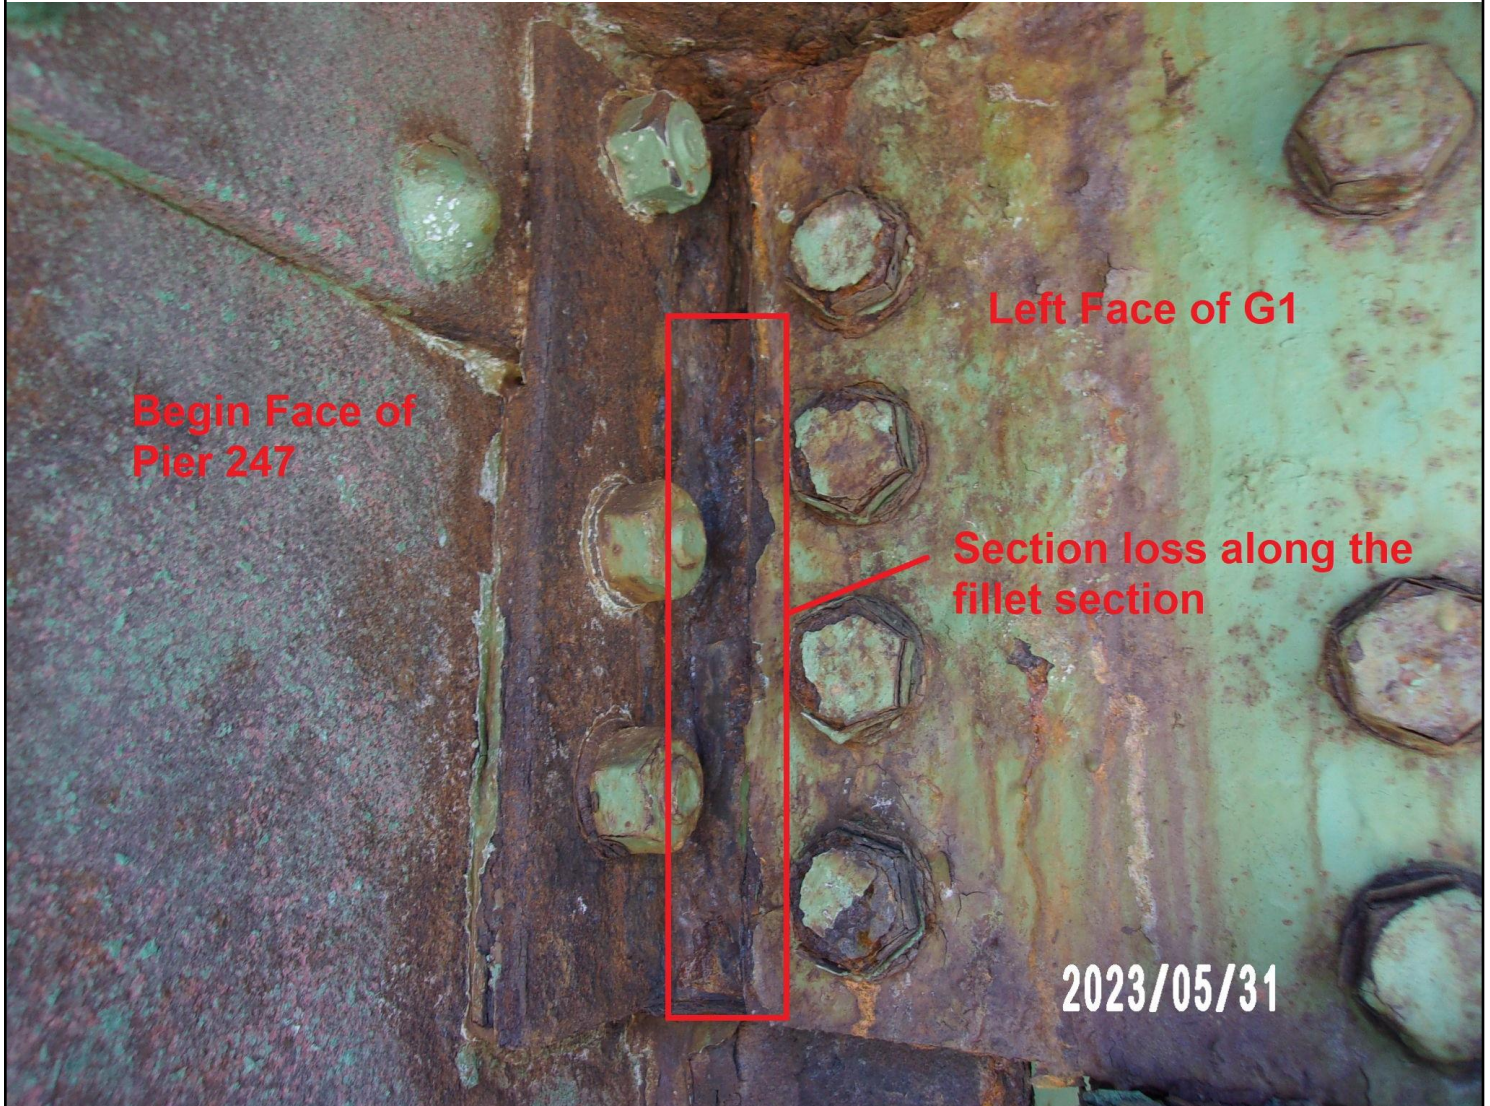
Photo Number: 5

Attachment Description: The left face of Girder G1 in Span 247 at Pier 247. The left connection angle exhibits up to 30% section loss in the fillet section below the crack at the top of the angle. Looking Right.

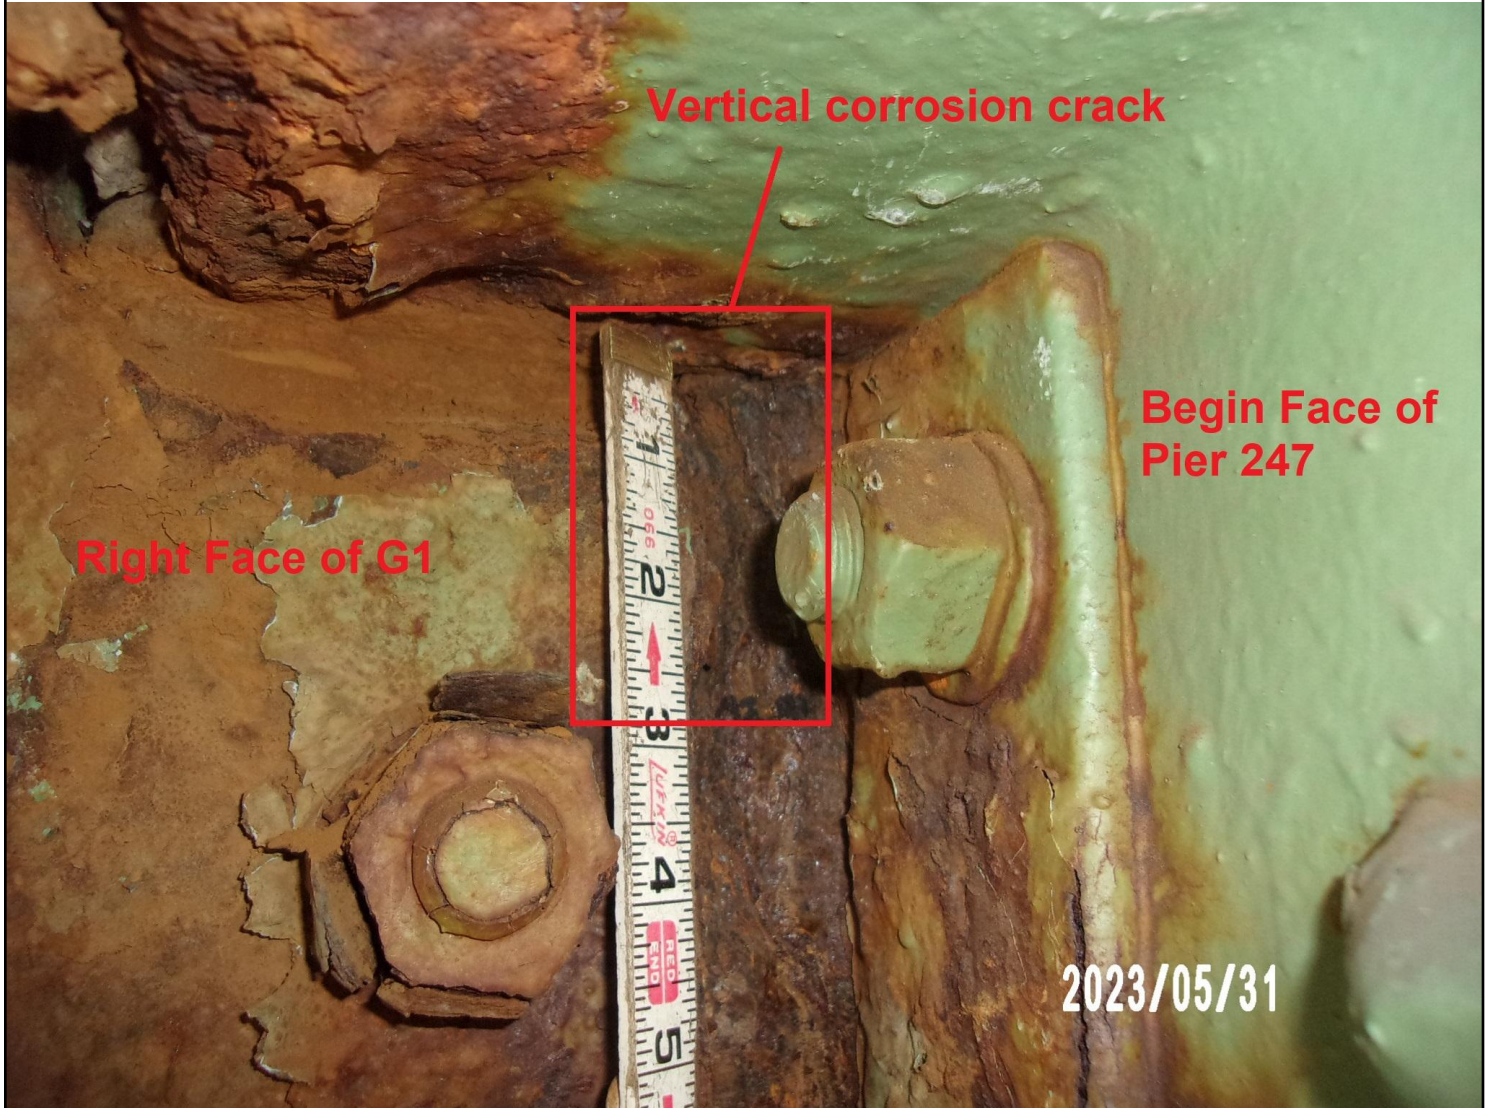
Photo Number: 6

The right stiffener connection angle exhibits a 2-3/4"H x 3/4"W vertical corrosion crack at the upper fillet section (Photo 6). The remaining 11-3/4" area of the fillet section below the corrosion crack at the top of the angle exhibits up to 40% section loss (Photo 7). The base of the stiffener connection angle exhibits up to 40% section loss for the full width for 4" high at the bottom of the stiffener (Photo 8).

Attachment Description: The right face of Girder G1 in Span 247 at Pier 247. The top of the right stiffener connection angle exhibits 2-3/4"H x 3/4"W corrosion crack at the fillet section. Looking Left.

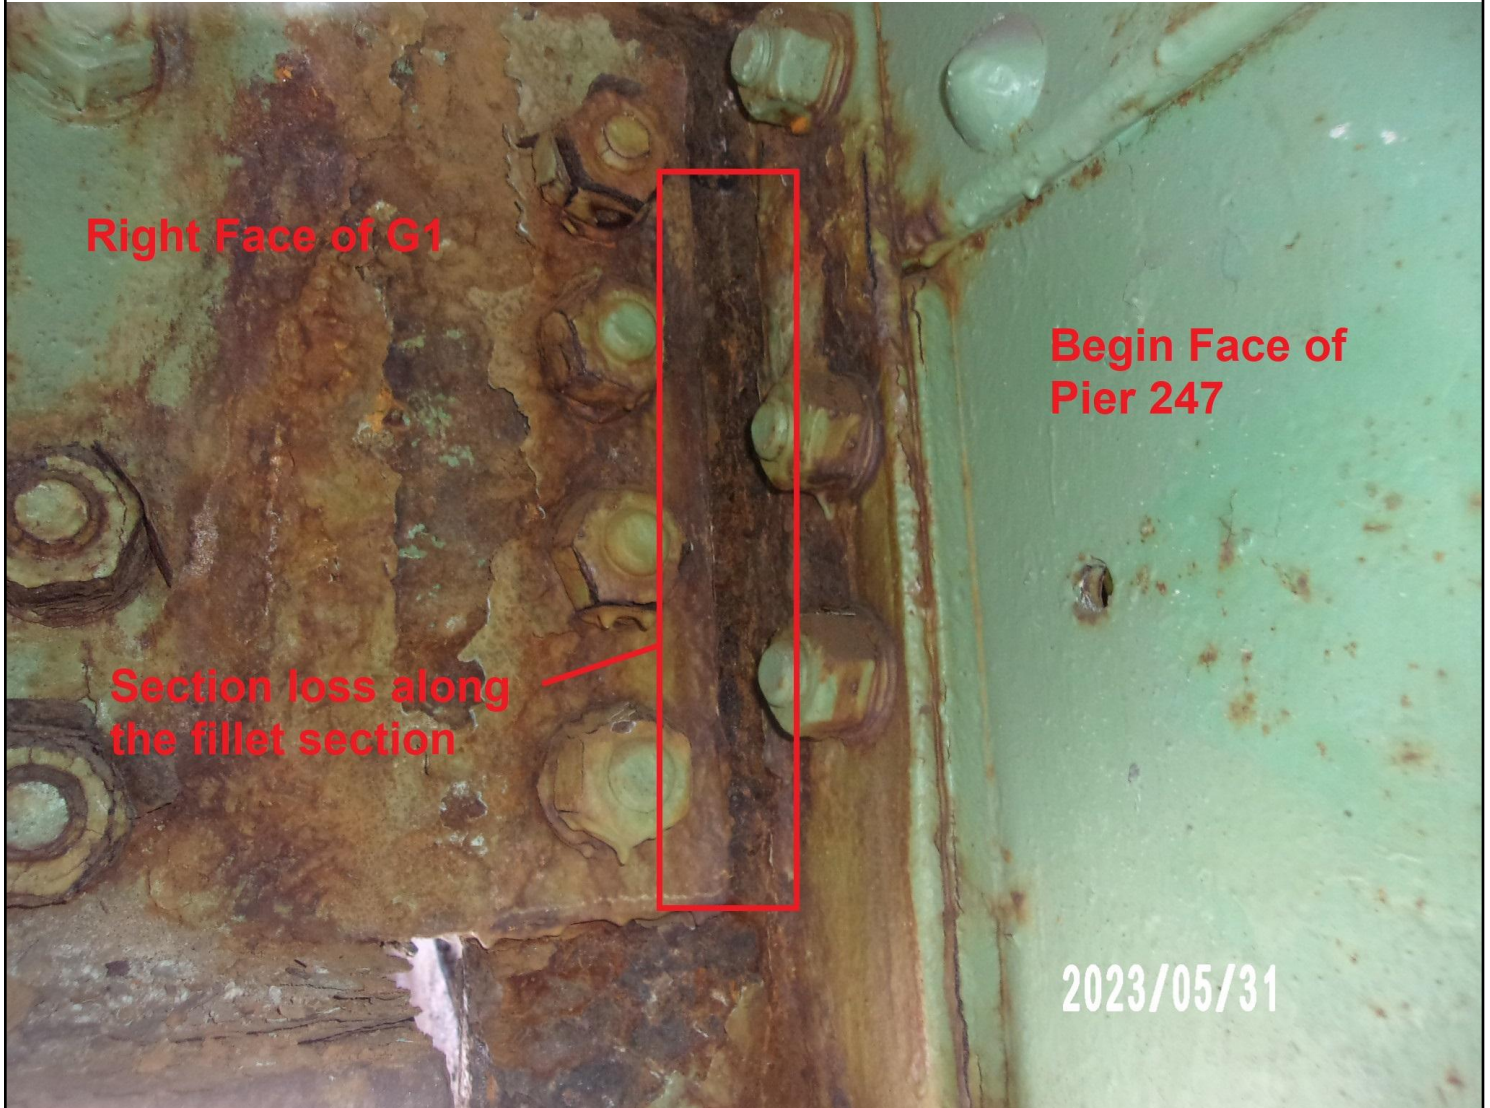
Photo Number: 7

Attachment Description: The right face of Girder G1 in Span 247 at Pier 247. The right stiffener connection angle exhibits up to 40% section loss in the fillet section below the crack at the top of the angle. Looking Left.

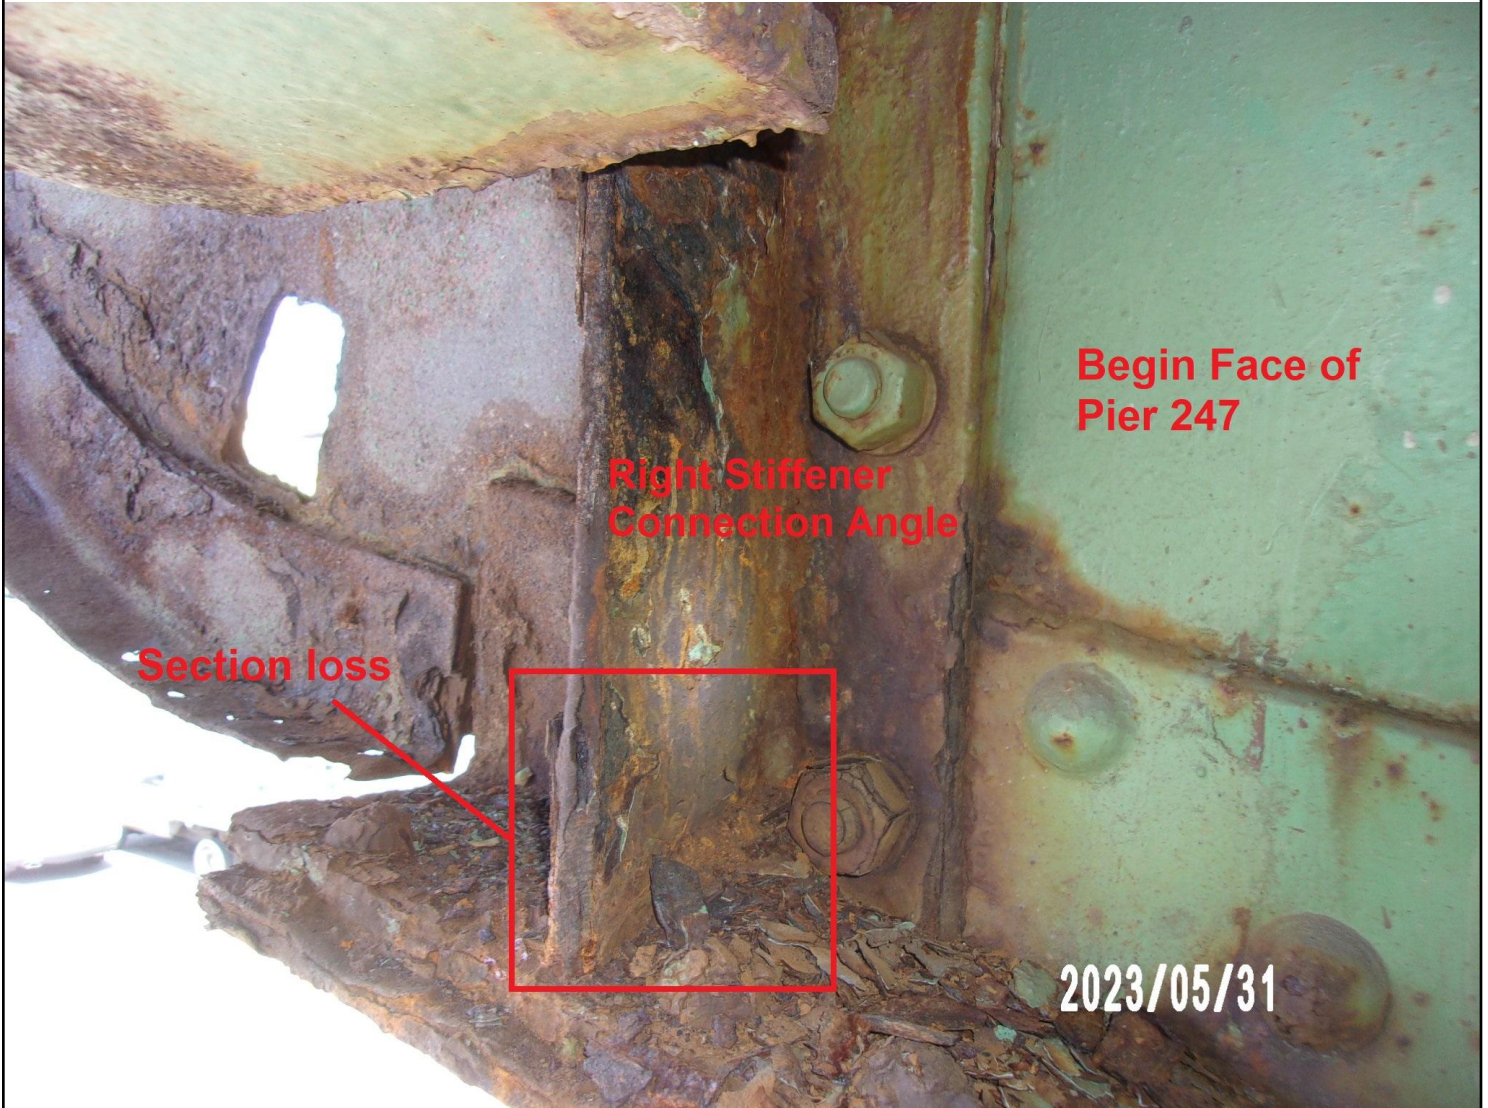
Photo Number: 8

Attachment Description: The base of the right stiffener connection angle at Girder G1 in Span 247 at Pier 247. The bottom of the right stiffener connection angle exhibits up to 40% section loss. Looking End and Left.
